MODEL  
2014MY  
Cadenza (VG)  
Optima (QF/TF)  
Sorento (XMa)

NUMBER  
062 (REV 2, 11/3/2014)

## TECHNICAL SERVICE BULLETIN

NAVIGATION UNIT SOFTWARE UPGRADE

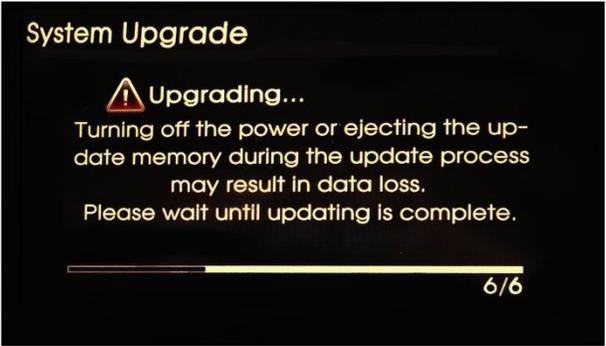
- If the update is completed successfully, the display will turn off. Once the Kia logo is displayed on the screen, cycle power to the navigation system by pressing the ON/OFF button.

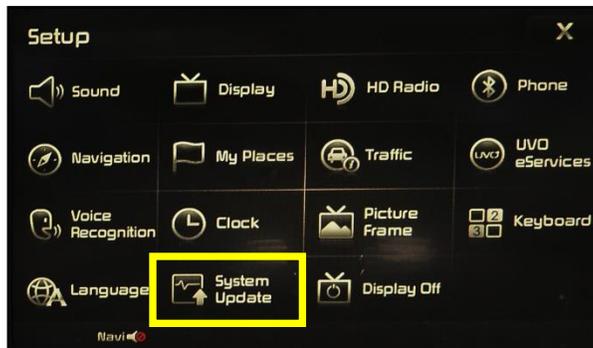
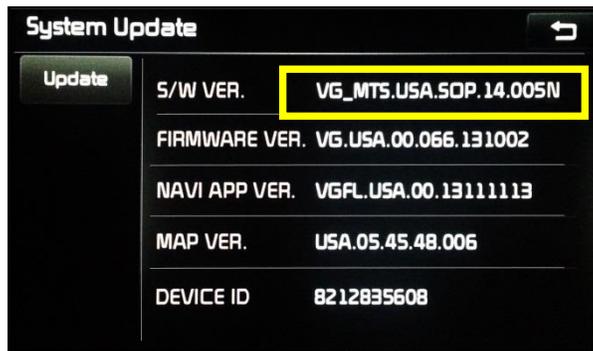
11. Confirm the upgraded software version matches the applicable information shown in the table below:
